Report No. VTRC 05-R31	Report Date June 2005	No. Pages 36	Type Report: Final Period Covered: August 2003-April 1, 2005	Project No.: 73849
				Contract No.
Title: Use of Soil Stabilizers on Highway Shoulders				Key Words: shoulders, soil stabilizers, soil additives, aggregates, shoulder reclaimer, pavement edge drop-off
Author: Daniel S. Roosevelt, P.E.				
Performing Organization Name and Address: Virginia Transportation Research Council 530 Edgemont Road Charlottesville, VA 22903				
Sponsoring Agencies' Name and Address Virginia Department of Transportation 1401 E. Broad Street Richmond, VA 23219				
Supplementary Notes				
<p>Abstract</p> <p>This study evaluated soil additives as stabilizers for aggregate and topsoil shoulders. Its purpose was to determine (1) the effect soil stabilizers have on the strength and stability of soil shoulders, and (2) the costs and benefits of using stabilizers versus paving the shoulder or maintaining the shoulder as originally composed. The study used test and control sections to assess two stabilization products, Soiltac and Centrophase AD, used with one type of shoulder material (crusher run stone). The experimental sections were installed at o

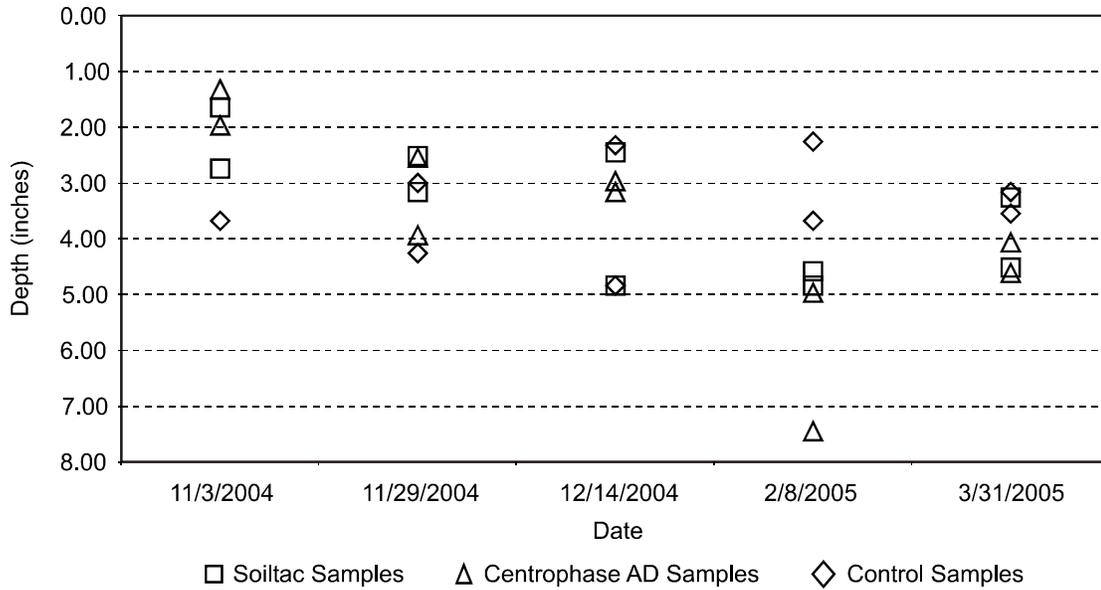
Figure 1. Initial DCP Penetration (at five blows), by Date

The DCP penetration data are shown in Appendix D. For convenient comparison with GeoGauge™ and visual inspection data, the DCP initial penetration data for each sample site are shown in Figure 1. To place these data in perspective, a CBR 10 material under controlled density and moisture conditions should produce DCP readings of approximately 0.8 in for every five blows.

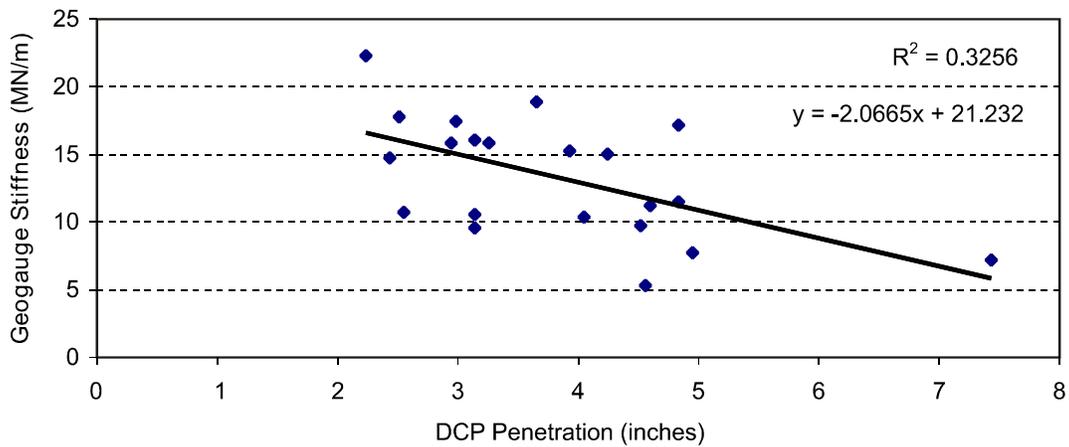
Figure 2. Scatter Plot of GeoGauge Stiffness Readings and DCP Readings for Corresponding Location and Date

A scatter plot comparison of the DCP and GeoGauge™ data collected on similar dates and locations is shown in Figure 2. The R² value indicates there is not a good correlation between the two sets of data.

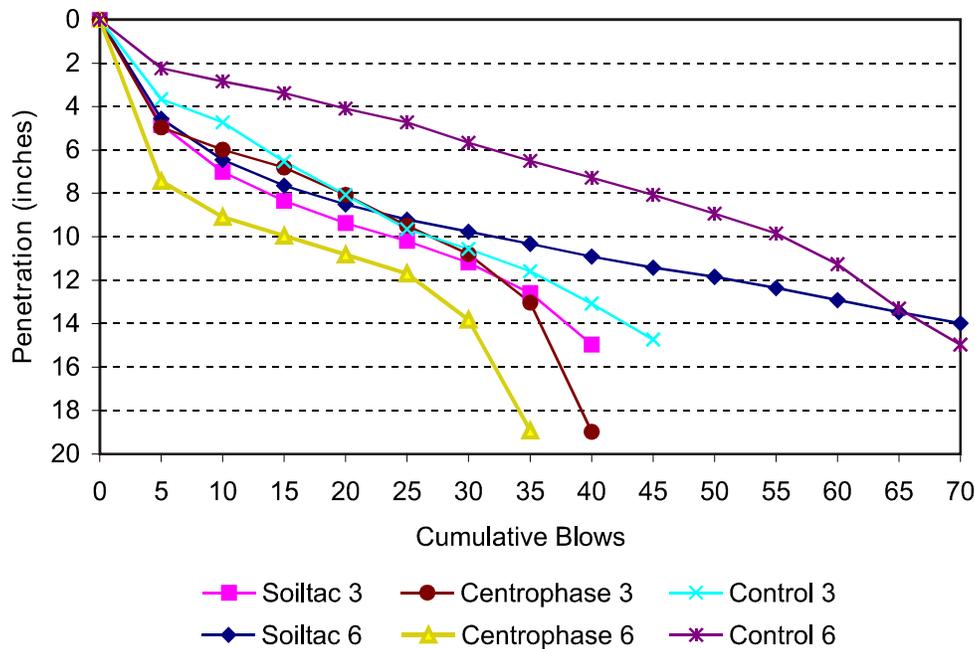
Figure 6. DCP Penetration Data, 2/8/2005

DCP penetration data for February 8 are shown in Figure 6. The data support the Geogauge and visual inspection data and indicate the lack of support extended well into the ground. The data showed that the full depth of the treated material in both test sections had lost strength. One of the Centrophase AD samples indicated the loss of strength extended well below the treated material.

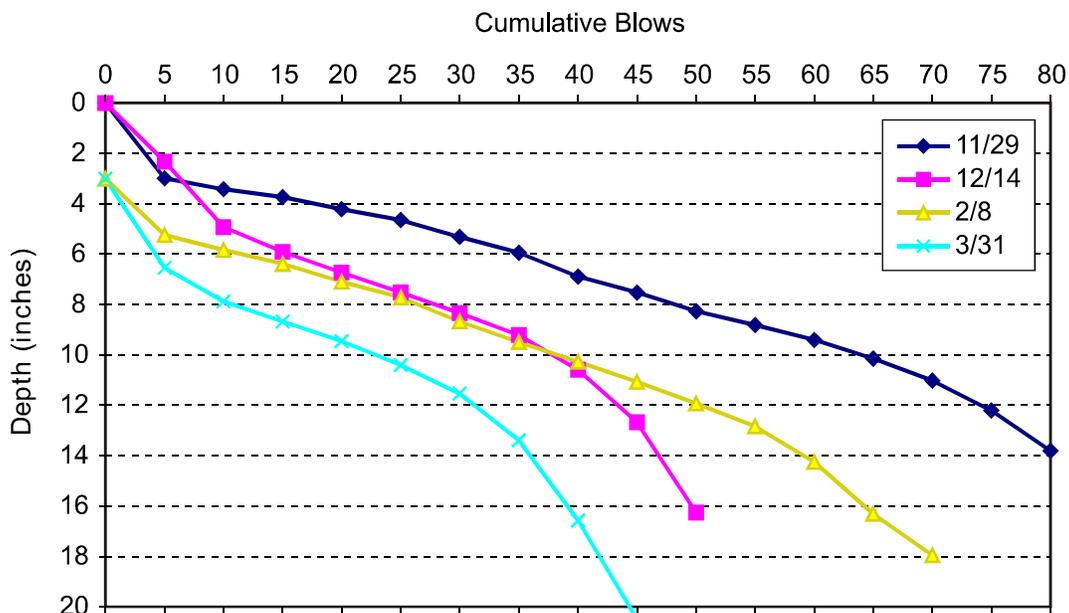
Figure 8. DCP Penetration Readings for Sample C-6 Adjusted for Shoulder Elevation

Although through traffic did not have a strong impact on the test and control sections, the condition of the shoulder at the private entrance gave some indication of the damage traffic running on the shoulder might do. DCP penetration data collected at C-6 over the life of the project are shown in Figure 8. The steeper the slope on the line connecting adjacent data points, the less resistant the material is to penetration. Although the shoulder area adjacent to C-6 showed some distress on the first two dates graphed, the low shoulder condition at this location did not become evident until the inspection of February 8. To account for the effect of the lost shoulder material and allow a better comparison of the data for the four dates, the zero point for the DCP penetration data was set 3 in lower for the February 8 and March 31 data.

The data support this scenario. On November 29, the capacity of the shoulder material to carry the traffic loads was lower in the first 3-in-depth of material than it was below that point. By December 14, traffic action caused the depth of reduced capacity (loose) material to reach 5 in. Sometime between December 14 and February 8, something caused the loose material to shift until the depth of the loose material returned to a depth of 2 in or less. At some point between December 14 and March 31, the cycle began again and the effect of traffic action on the shoulder caused the depth of loose material to increase. Without maintenance, when the loose material reaches a depth of 5 in or more, the deformation will occur again and increase the size and depth of the hole.

- The shoulder surface material was placed and compacted on September 1, and destabilization of the shoulder because of light, but recurring, traffic occurred between December 14 and February 8, suggesting a maintenance cycle under these conditions of 3 to 5 months.
- Comparison of the December 14 DCP data for C-6 (Figure 8) and the February 8 DCP data for the two test sections (Figure 6) indicates the test sections had loose material with higher penetration numbers to a depth equal to or greater than that of the material at C-6. Deformation had not occurred at the test section DCP data points, but these points lacked the recurring traffic that C-6 experienced.
